Engineering Project Report - EPR2012-06

DoubleTrac UV Testing / Product Validation

Validate and verify the accelerated UV aging of DoubleTrac Piping.

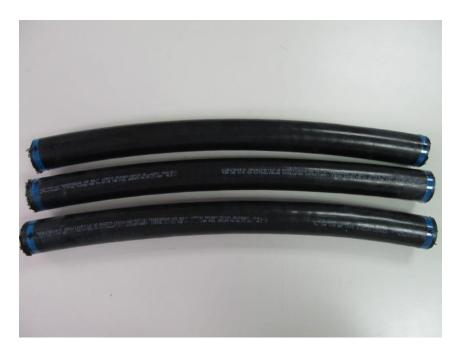
Photograph #1: Representative Overview of Submitted Tube Samples, As-received

Photographs #1 and #2, below, display representative overviews of the submitted tube samples as-received and within the chamber housing.

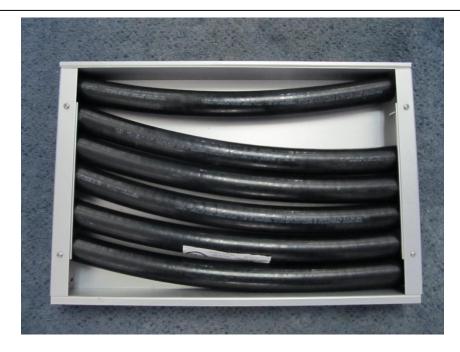
Photograph #2: Representative Overview of Submitted Tube Samples Within Chamber Housing

The samples were loaded such that one (1) "side" of the tube saw continuous UV exposure. The opposite "side" of the tube saw no UV exposure.

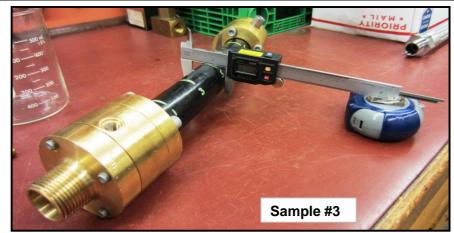
Outside Diameter measured at the following locations before adding test fluid to the interstitial space (from left to right):

EFEP Secondary Barrier Jacket

Interstitial space capacity at 100%
 50 mL
 tap water & glass beaker used to determine capacity

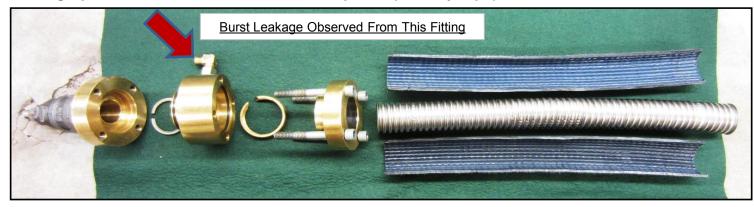
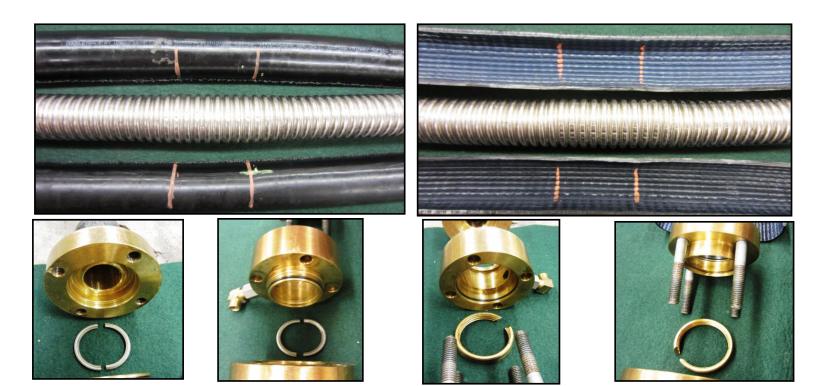
Photographs After Burst & Crush Test - Sample #1 (Primary Pipe)

Determine:	Size	Test Pressure	Test Time	Increase Test Pressure	Test Time		
Sample #1	1"	125 psig	1 minute	625 psig	1 minute		
	RESULTS	Satisfactory - No D	amage or Leakage	e Observed			
Determine:	e: Size Increase Test Pressure until the primary 1" DoubleTrac assembly burst.						
Sample #1	1"	Test Pressure at Burst:					
	RESULTS	BURST at 1,403 PS	l (Leakage Observ	ved From The Secondary Barrie	r Fill Fitting.		
Burst Test Secondary:							
Determine:	Size	Test Pressure	Test Time	Increase Test Pressure	Test Time		
Sample #2	1"	50 psig	1 minute	125 psig	1 minute		
	RESULTS	Satisfactory - No D	amage or Leakage	e Observed			
Determine	0:

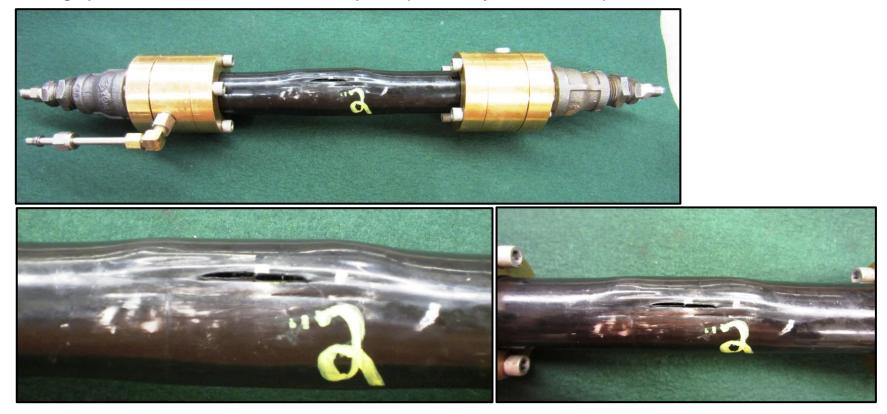
Photographs After Burst & Crush Test - Sample #2 (Secondary Barrier Jacket)

Determine:	Size	Increase Test Pressure until the secondary 1" DoubleTrac assembly burst.	
Sample #2	1"	Test Pressure at Burst:	
RESULTS: BURST at 494 PSI (Leakage Observed From The Outer Jacket
